Dust Monitoring Test Report

To:	115 Richards Road, Dairy Flat
From:	Waste Management-Redvale
Date:	5 November 2025
Sampling Location:	Driveway fence at 115 Richards Rd and the southern boundary of Redvale Landfill
Sampling Source:	Airborne Dust
Analysis institution:	Capital Environmental Services

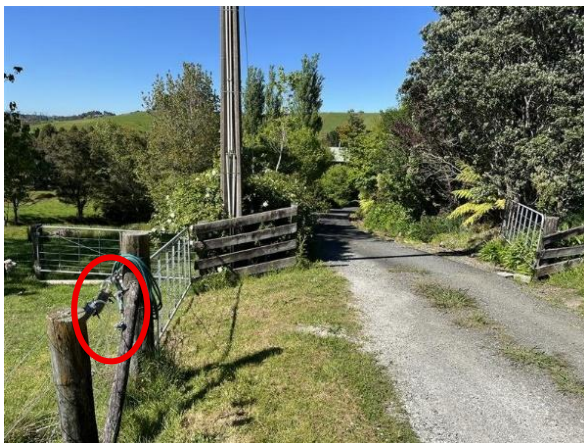
Two dust samples (one inhalable and one respirable) were placed on the driveway fence at 115 Richards Road, with the sampling heads oriented toward the nearby landfill (Figure 1). This location was selected because it is an open, unobstructed area that represents the point of highest dust exposure at the residence.

Figure 1. Dust monitoring at the driveway fence of 115 Richards Road

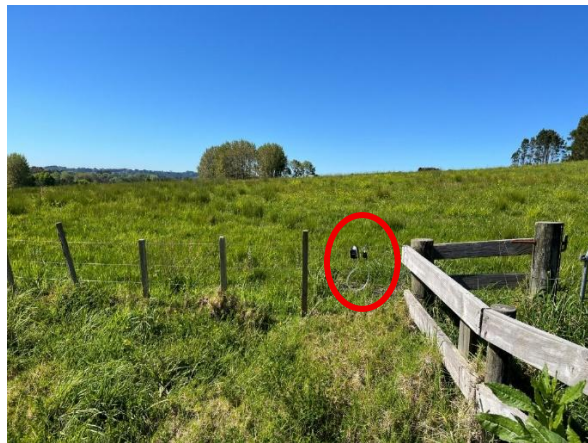
To characterize potential dust sources, an additional inhalable dust sample was collected at the southern boundary of the landfill (Figure 2), positioned in line with the direction from the landfill toward the residence. The straight-line distance between the monitoring location at 115 Richards Road and the landfill boundary sampling point is 377 m. The spatial relationship between all monitoring locations and the landfill is shown in Figure 3.

Figure 2. Dust monitoring at southern boundary of Redvale Landfill

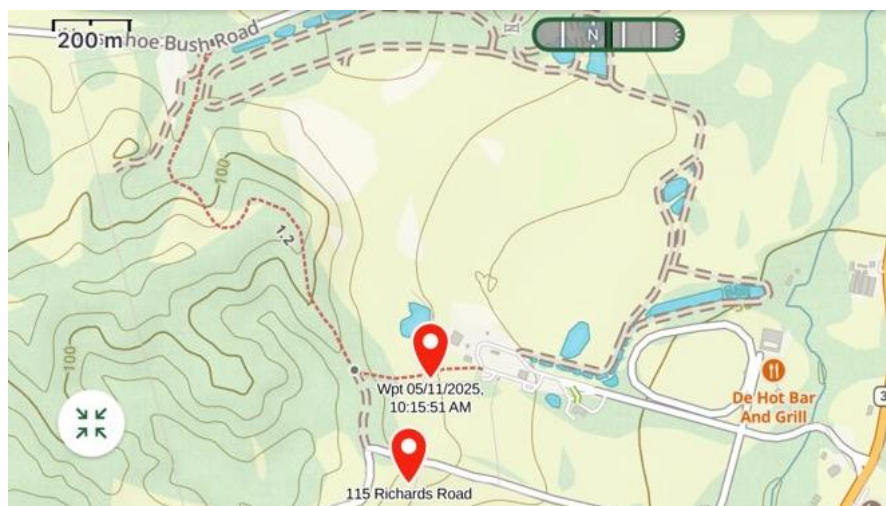
Figure 3. Spatial relationship between dust monitoring locations relative to the nearby landfill
